IDENTIFICATION OF INTEFERENCE HV LINE PROTECTION IN PLGTU PT PJB GRESIK GENERATION UNIT USING METHOD RCFA AND FDT

¹Resti Pranandari, ²Misbah, ³Deny Irawan

^{1,2,3} Electrical Engineering, Universitas Muhammadiyah Gresik

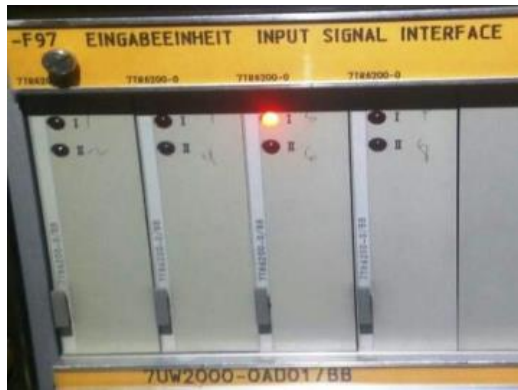
Figure 4. GTG No.3 HV Line protection trip alarm

In figure 4. There is an alarm on GTG no.3 indicating the HV Line protection trip which gives trip orders to the unit generator.

- In the event trace OPS alarm block 1
- 18:21 Alarm GTG NO.3 HV LINE Prot. Trip
- 18:21 Alarm NO 3 GT Electrical Fault Trip
- 18:21 Alarm NO 3 GTG MCB Open
- 18:21 #3GT Trip

- No. 14 matrices: Under Frequency
- No. 30 matrices: Branch and breaker failure prot

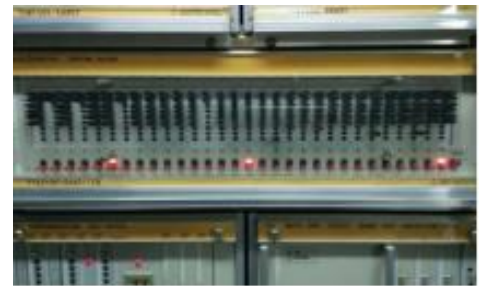
Figure 5. STG No.3 HV Line protection trip alarm

In figure 5. There is an alarm on STG no.1 indicating that HV Line protection trip which gives trip orders to the unit generator.

- In the event trace OPS alarm block 1
- 06.36 Alarm STG NO.1 HV LINE PROTECTION TRIP
- 06.36 Alarm ST Generator Trip Condition
- 06.36 Alarm ST Trip On
- Generator Protection Panel ST #1.0:
- No. 06 matrix: Reverse Power
- No. 16 matrices: Excitation Failure
- No. 30 matrices: Branch and Breaker Failure Protection

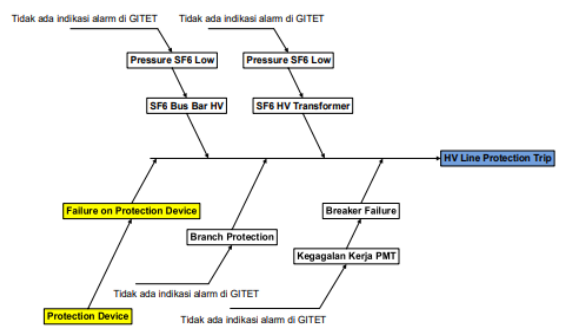
Figure 6. fishbone diagram of protection HV Line and equipment support on protection HV Line

Check for possible unit faults as follows:

- Work in the PLGTU area
 - a. F97 input cable looping test

- b. Megger input cable to F97 channel 1 and channel 2 (cable from the direction of GITET to PLGTU)

- Jobs in the GITET area:

- a. Check the contacts of the BBF protection F513
- b. Measurement of contact resistance value of the BBF relay protection F513

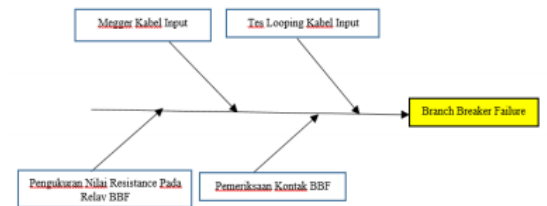
Figure 7. fishbone diagram BBF

In figure 7, Fishbone Diagram on Branch Breaker Failure which includes input cable looping test, cable megger, measurement resistance value, and checking the BBF contacts.

- Work in the PLGTU area
 - a. F97 input cable looping test
 - b. Megger input cable to F97
 - c. Measurement of the resistance contact value on Branch Breaker Failure relay

It can be seen from the measurement data that the failure that occurs in the protection HV Line is due to a false signal from the transmission which results in a Unit Trip. The false signal works even though there is no trip command from the transmission or generator, but the generator receives a trip command, causing the generator unit to trip. After further identification using the RCFA method in which there is a fishbone diagram, it is known that the failure occurred due to damage to the Branch breaker failure.
