# Technical Analysis of Lightning Arrester Replacement to Improve Customer's Power Grid Reliability

<sup>3</sup>PT. PLN (Persero) ULP Ngagel, Surabaya, 60283, Indonesia

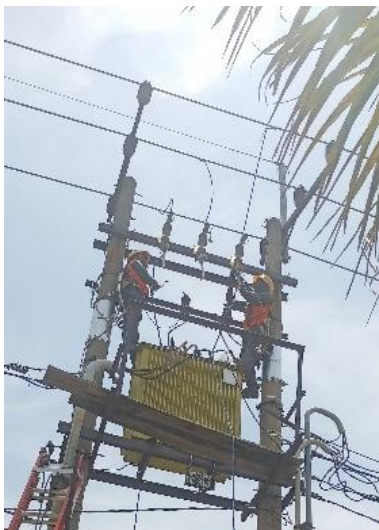
Figure 2. The Lightning Arrester replacement work was carried out by the HAR-C team PT. PLN (Persero) ULP Ngagel

The execution process in the field follows a series of methodical stages designed to guarantee system integrity and occupational safety. The initial stage involves quantifying existing operational parameters, namely measuring the output voltage and load current of the transformer to obtain baseline data. After that, a planned temporary power outage is carried out, followed by the process of dismantling the old lightning arrester unit and installing the new unit with precision. Every step in this procedure is carried out in accordance with standard operational protocols to minimize the duration of outages and potential technical risks.

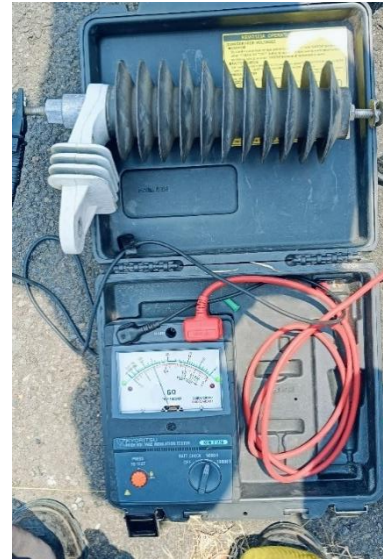
Figure 3. Lightning Arrester isolation detention measurement

The final stage is the verification and validation phase, which is crucial to confirm the success of the intervention. Comprehensive testing was carried out on the customer-serving LVMDP (Low Voltage Main Distribution Panel) panel, including post-installation voltage and current re-measurements. More importantly, insulation resistance testing is performed, which is a critical parameter for assessing the health of the protective device. The purpose of this final validation is to ensure the conformity of the functionality of the device with the established safety and operational reliability standards, so that it can be ensured that the system is back in optimal and safe operation.
