IDENTIFICATION OF INTEFERENCE HV LINE PROTECTION IN PLGTU PT PJB GRESIK GENERATION UNIT USING METHOD RCFA AND FDT

¹Resti Pranandari, ²Misbah, ³Deny Irawan

^{1,2,3} Electrical Engineering, Universitas Muhammadiyah Gresik

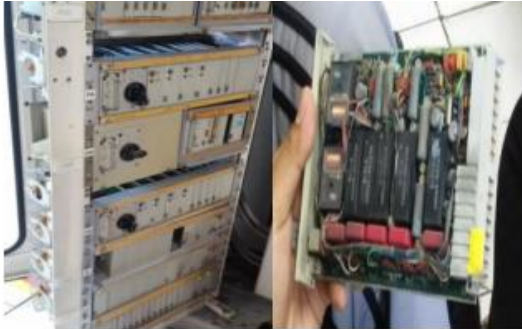
Figure 7 examinations and relay installation in PLGTU and GITET area

- Jobs in the GITET area:

- a. Check the contacts of the BBF protection F513
- b. Measurement of contact resistance value of the BBF relay protection F513
